Swarr Run Floodplain Restoration

Mid-Atlantic Wetlands Workgroup

November 15, 2023

Presented by Justin Spangler, PE
Justin@LandStudies.com

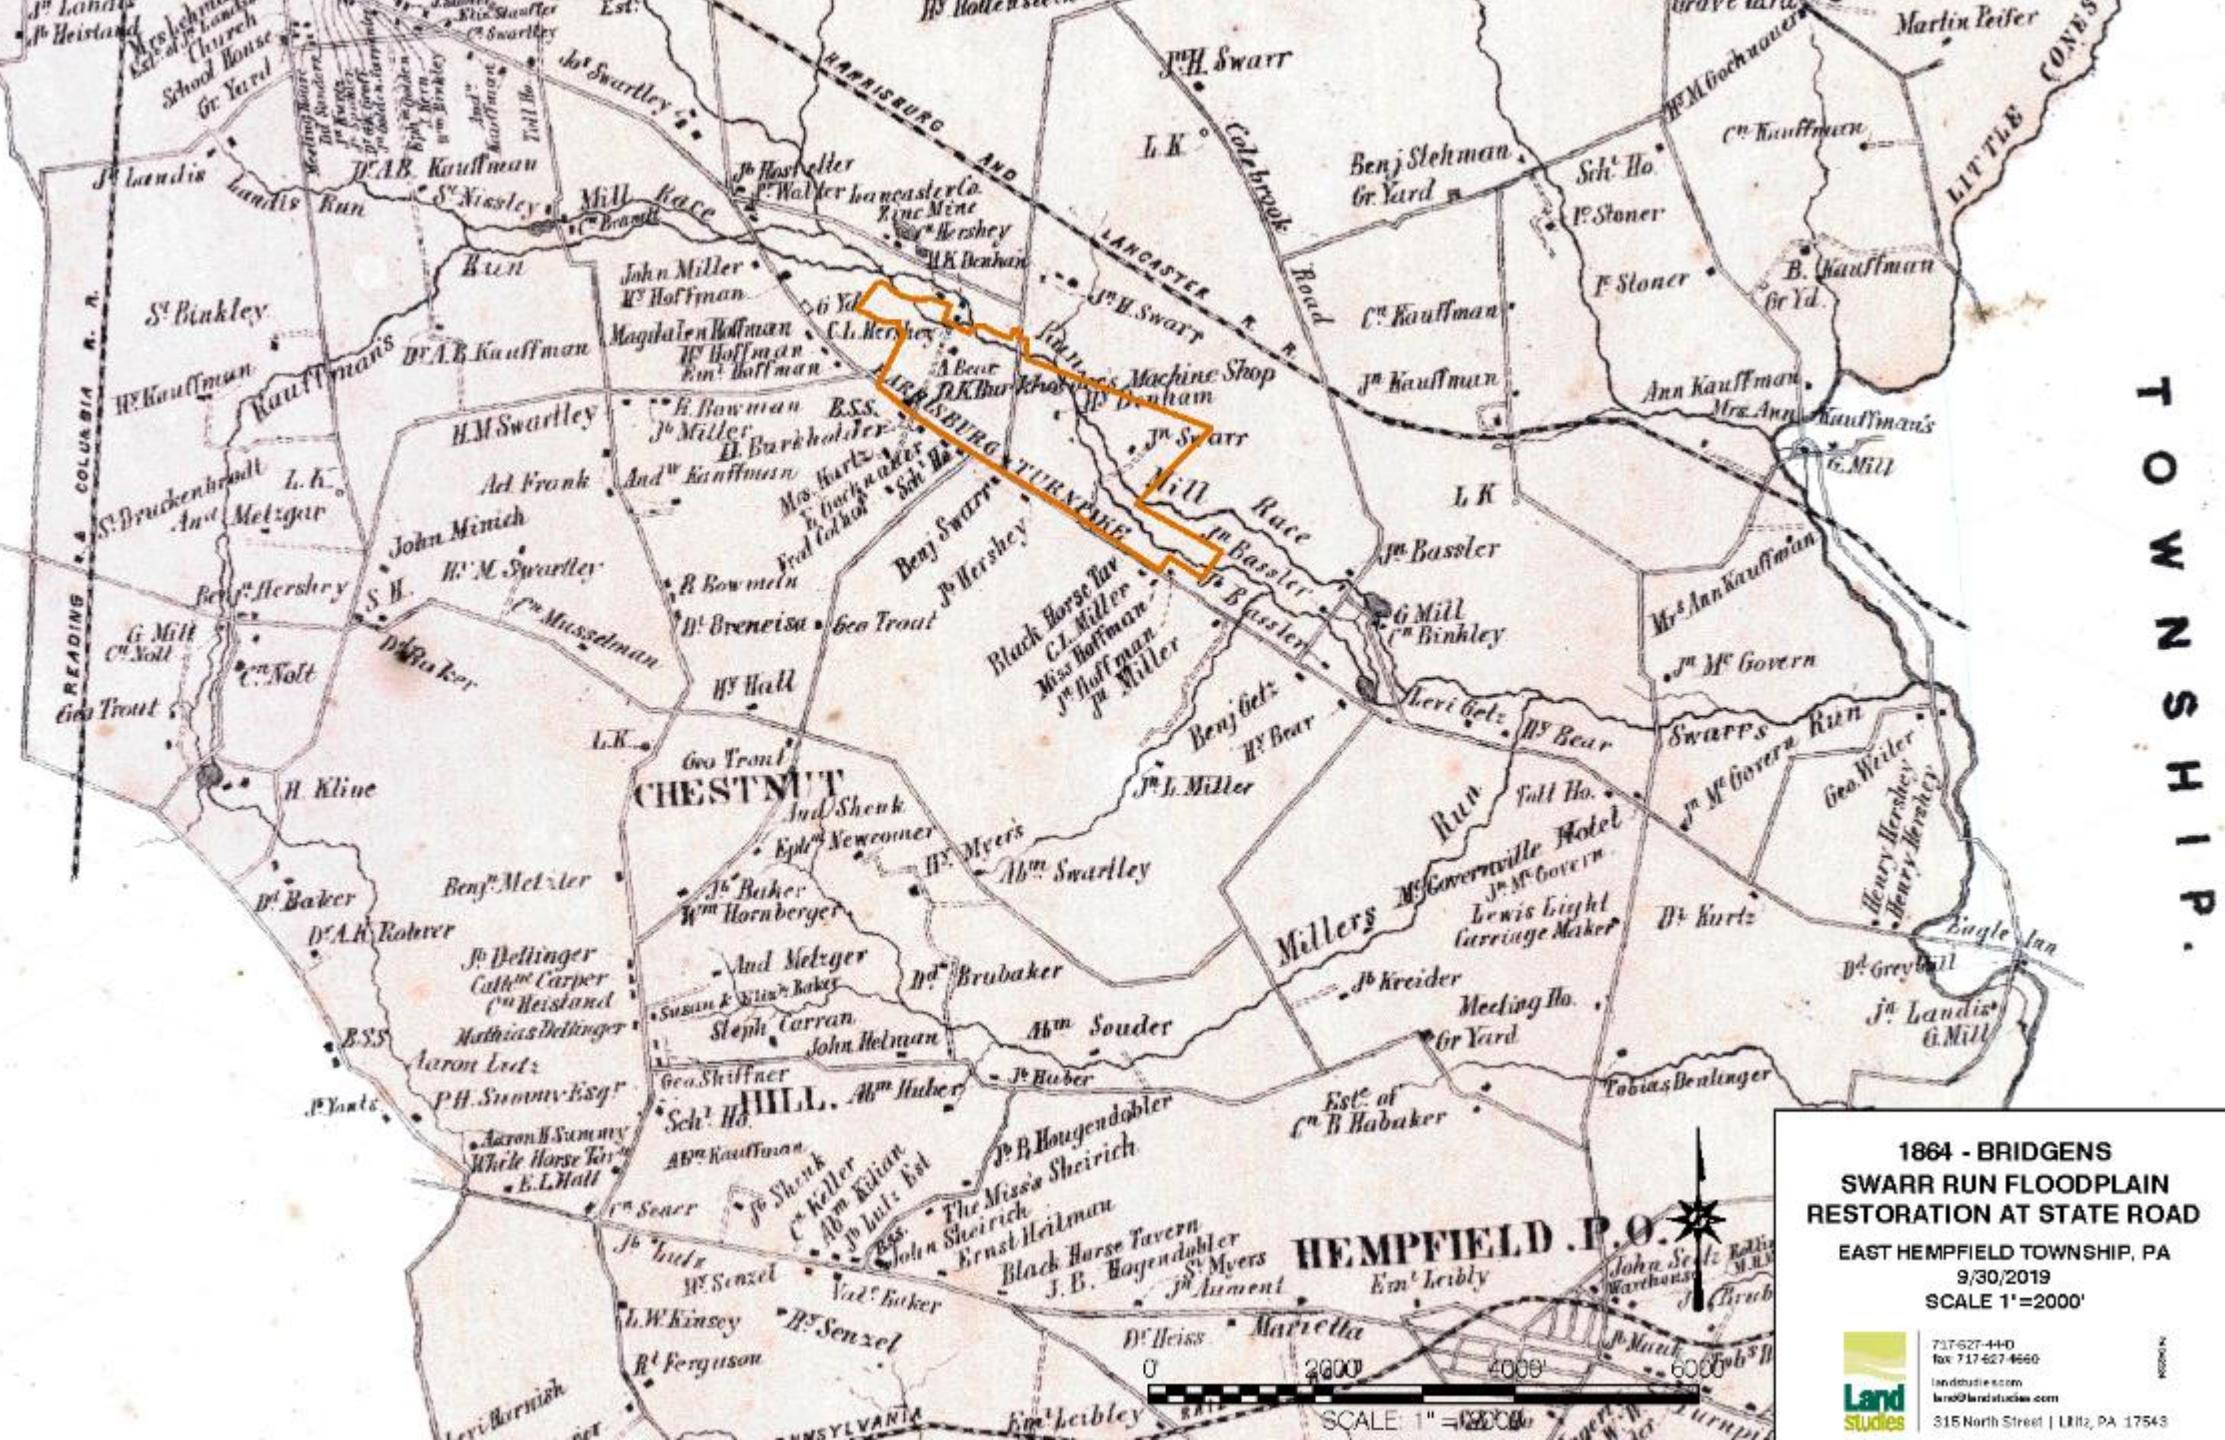
1864 - BRIDGENS
SWARR RUN FLOODPLAIN
RESTORATION AT STATE ROAD

EAST HEMPFIELD TOWNSHIP, PA

SCALE 1'=2000'

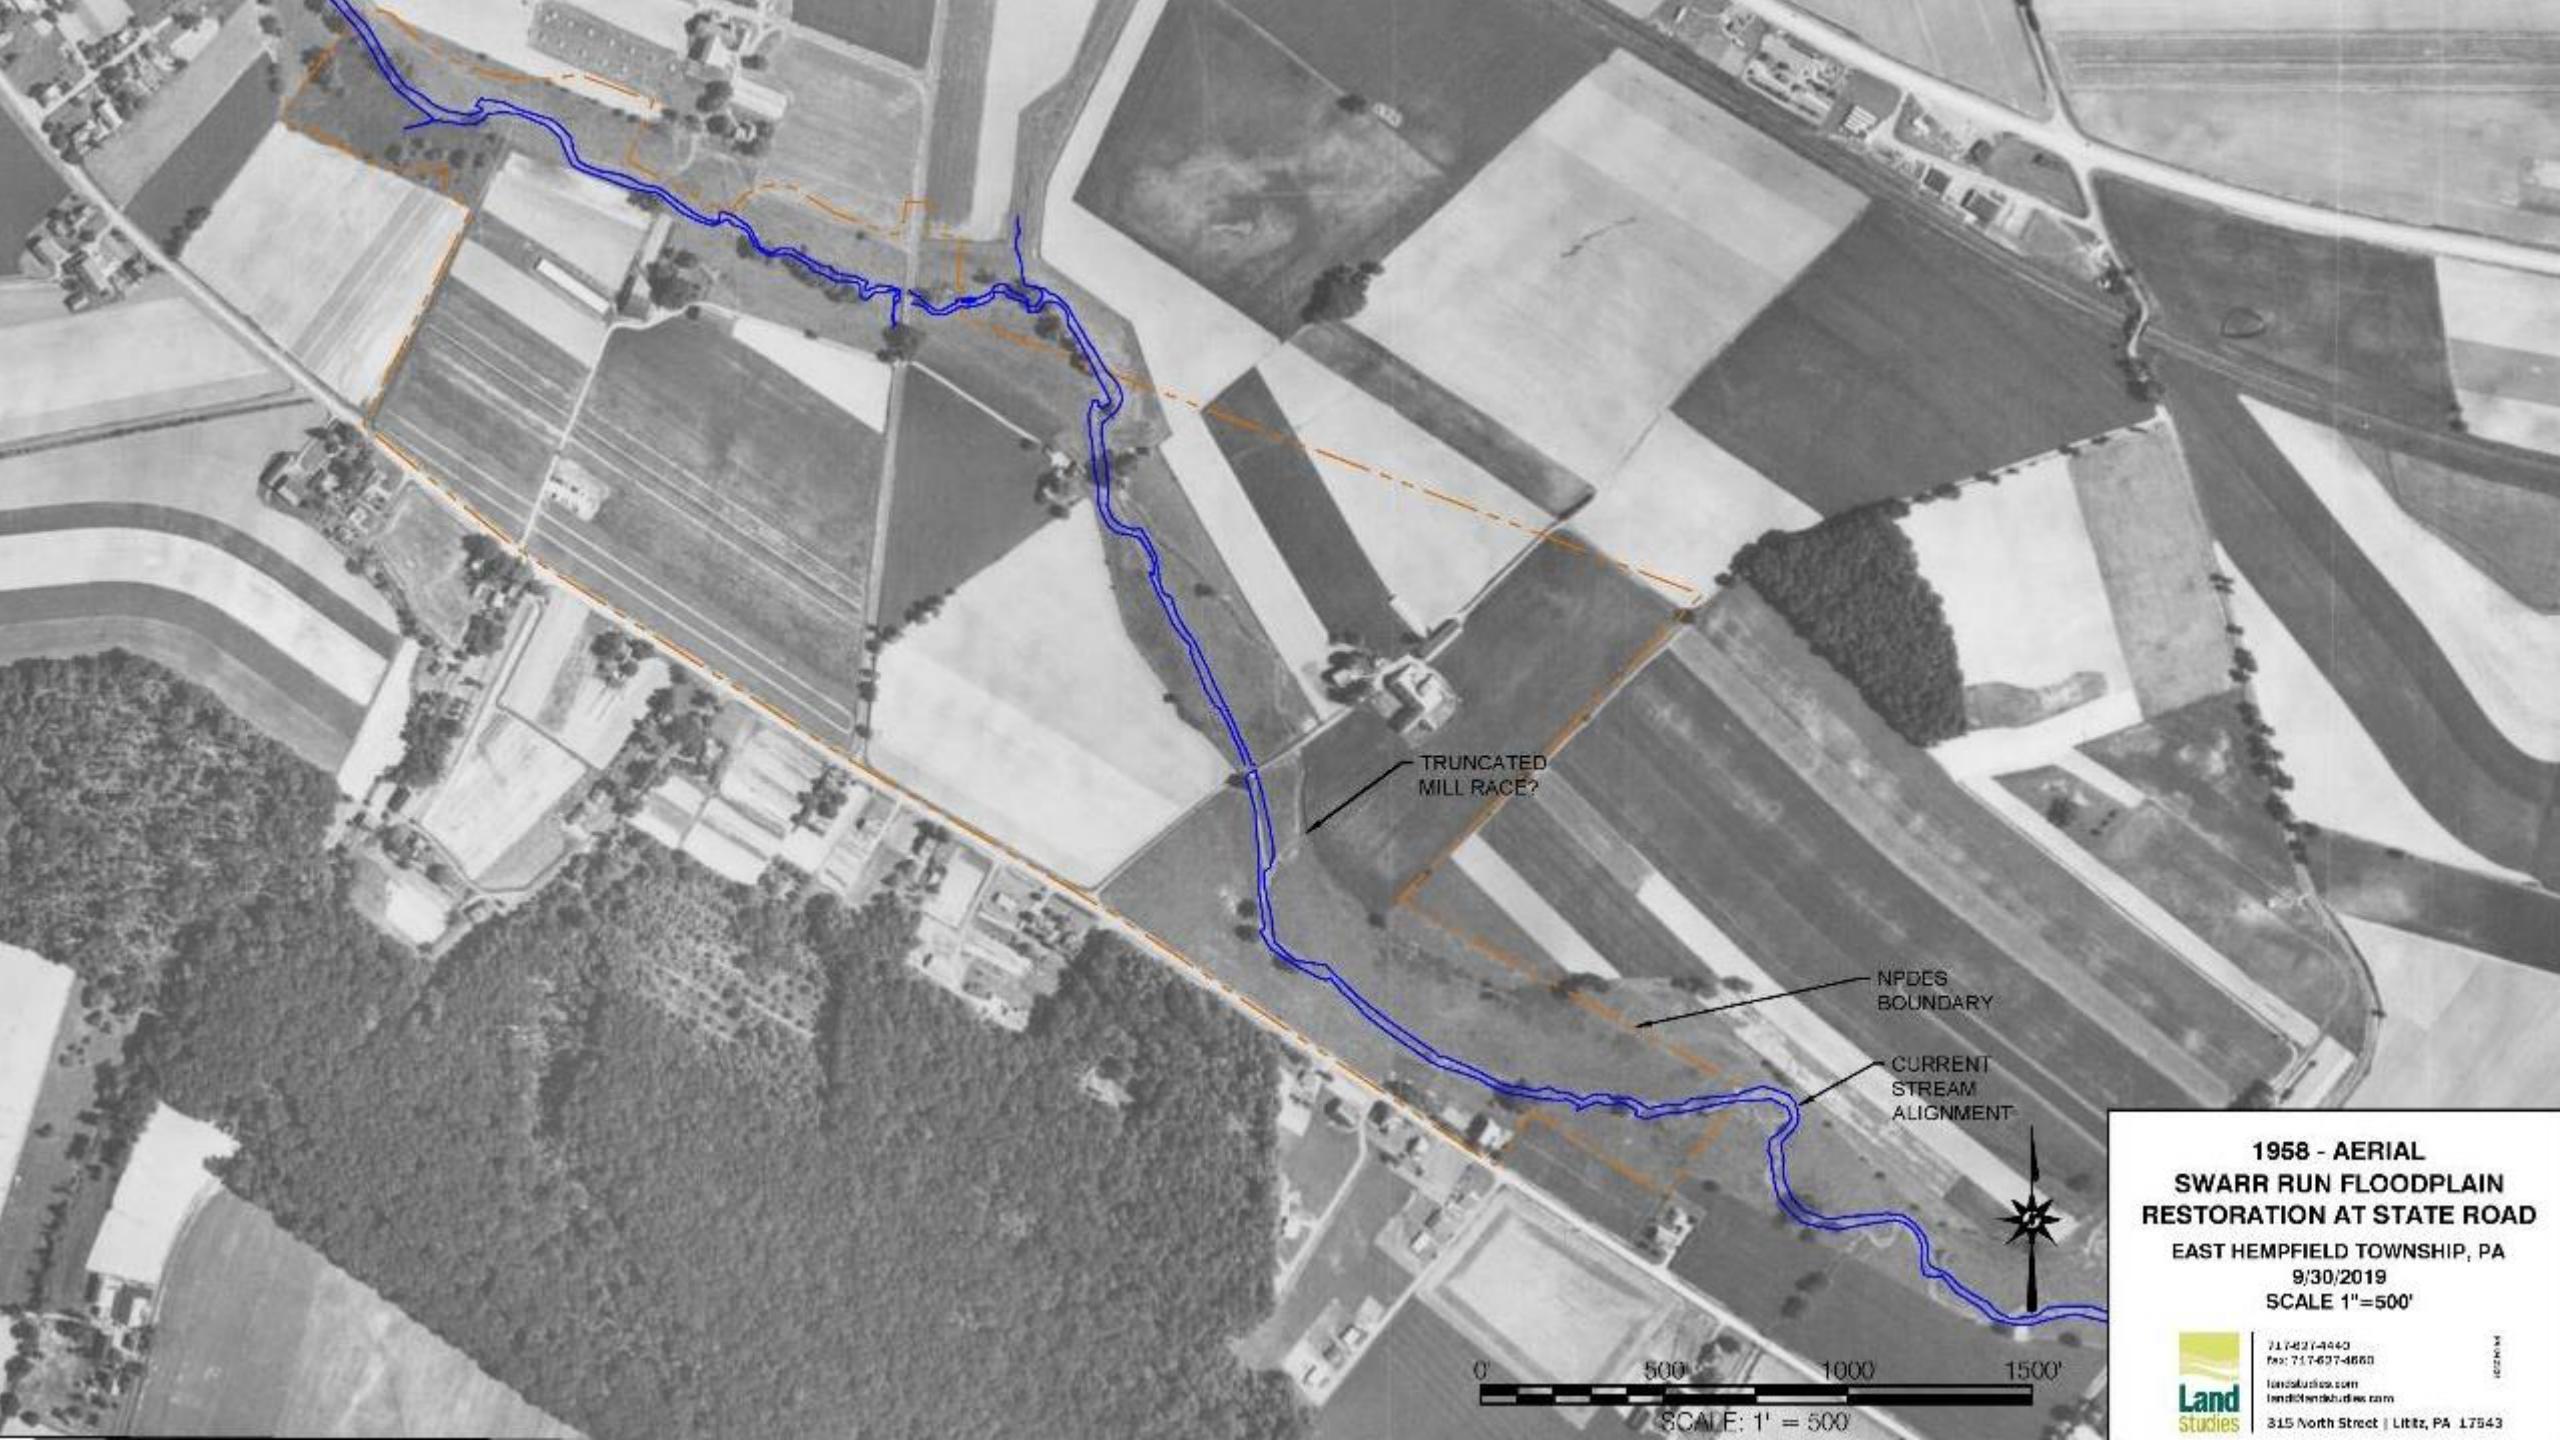
1958 - AERIAL
SWARR RUN FLOODPLAIN
RESTORATION AT STATE ROAD

EAST HEMPFIELD TOWNSHIP, PA

SCALE 1"=500'

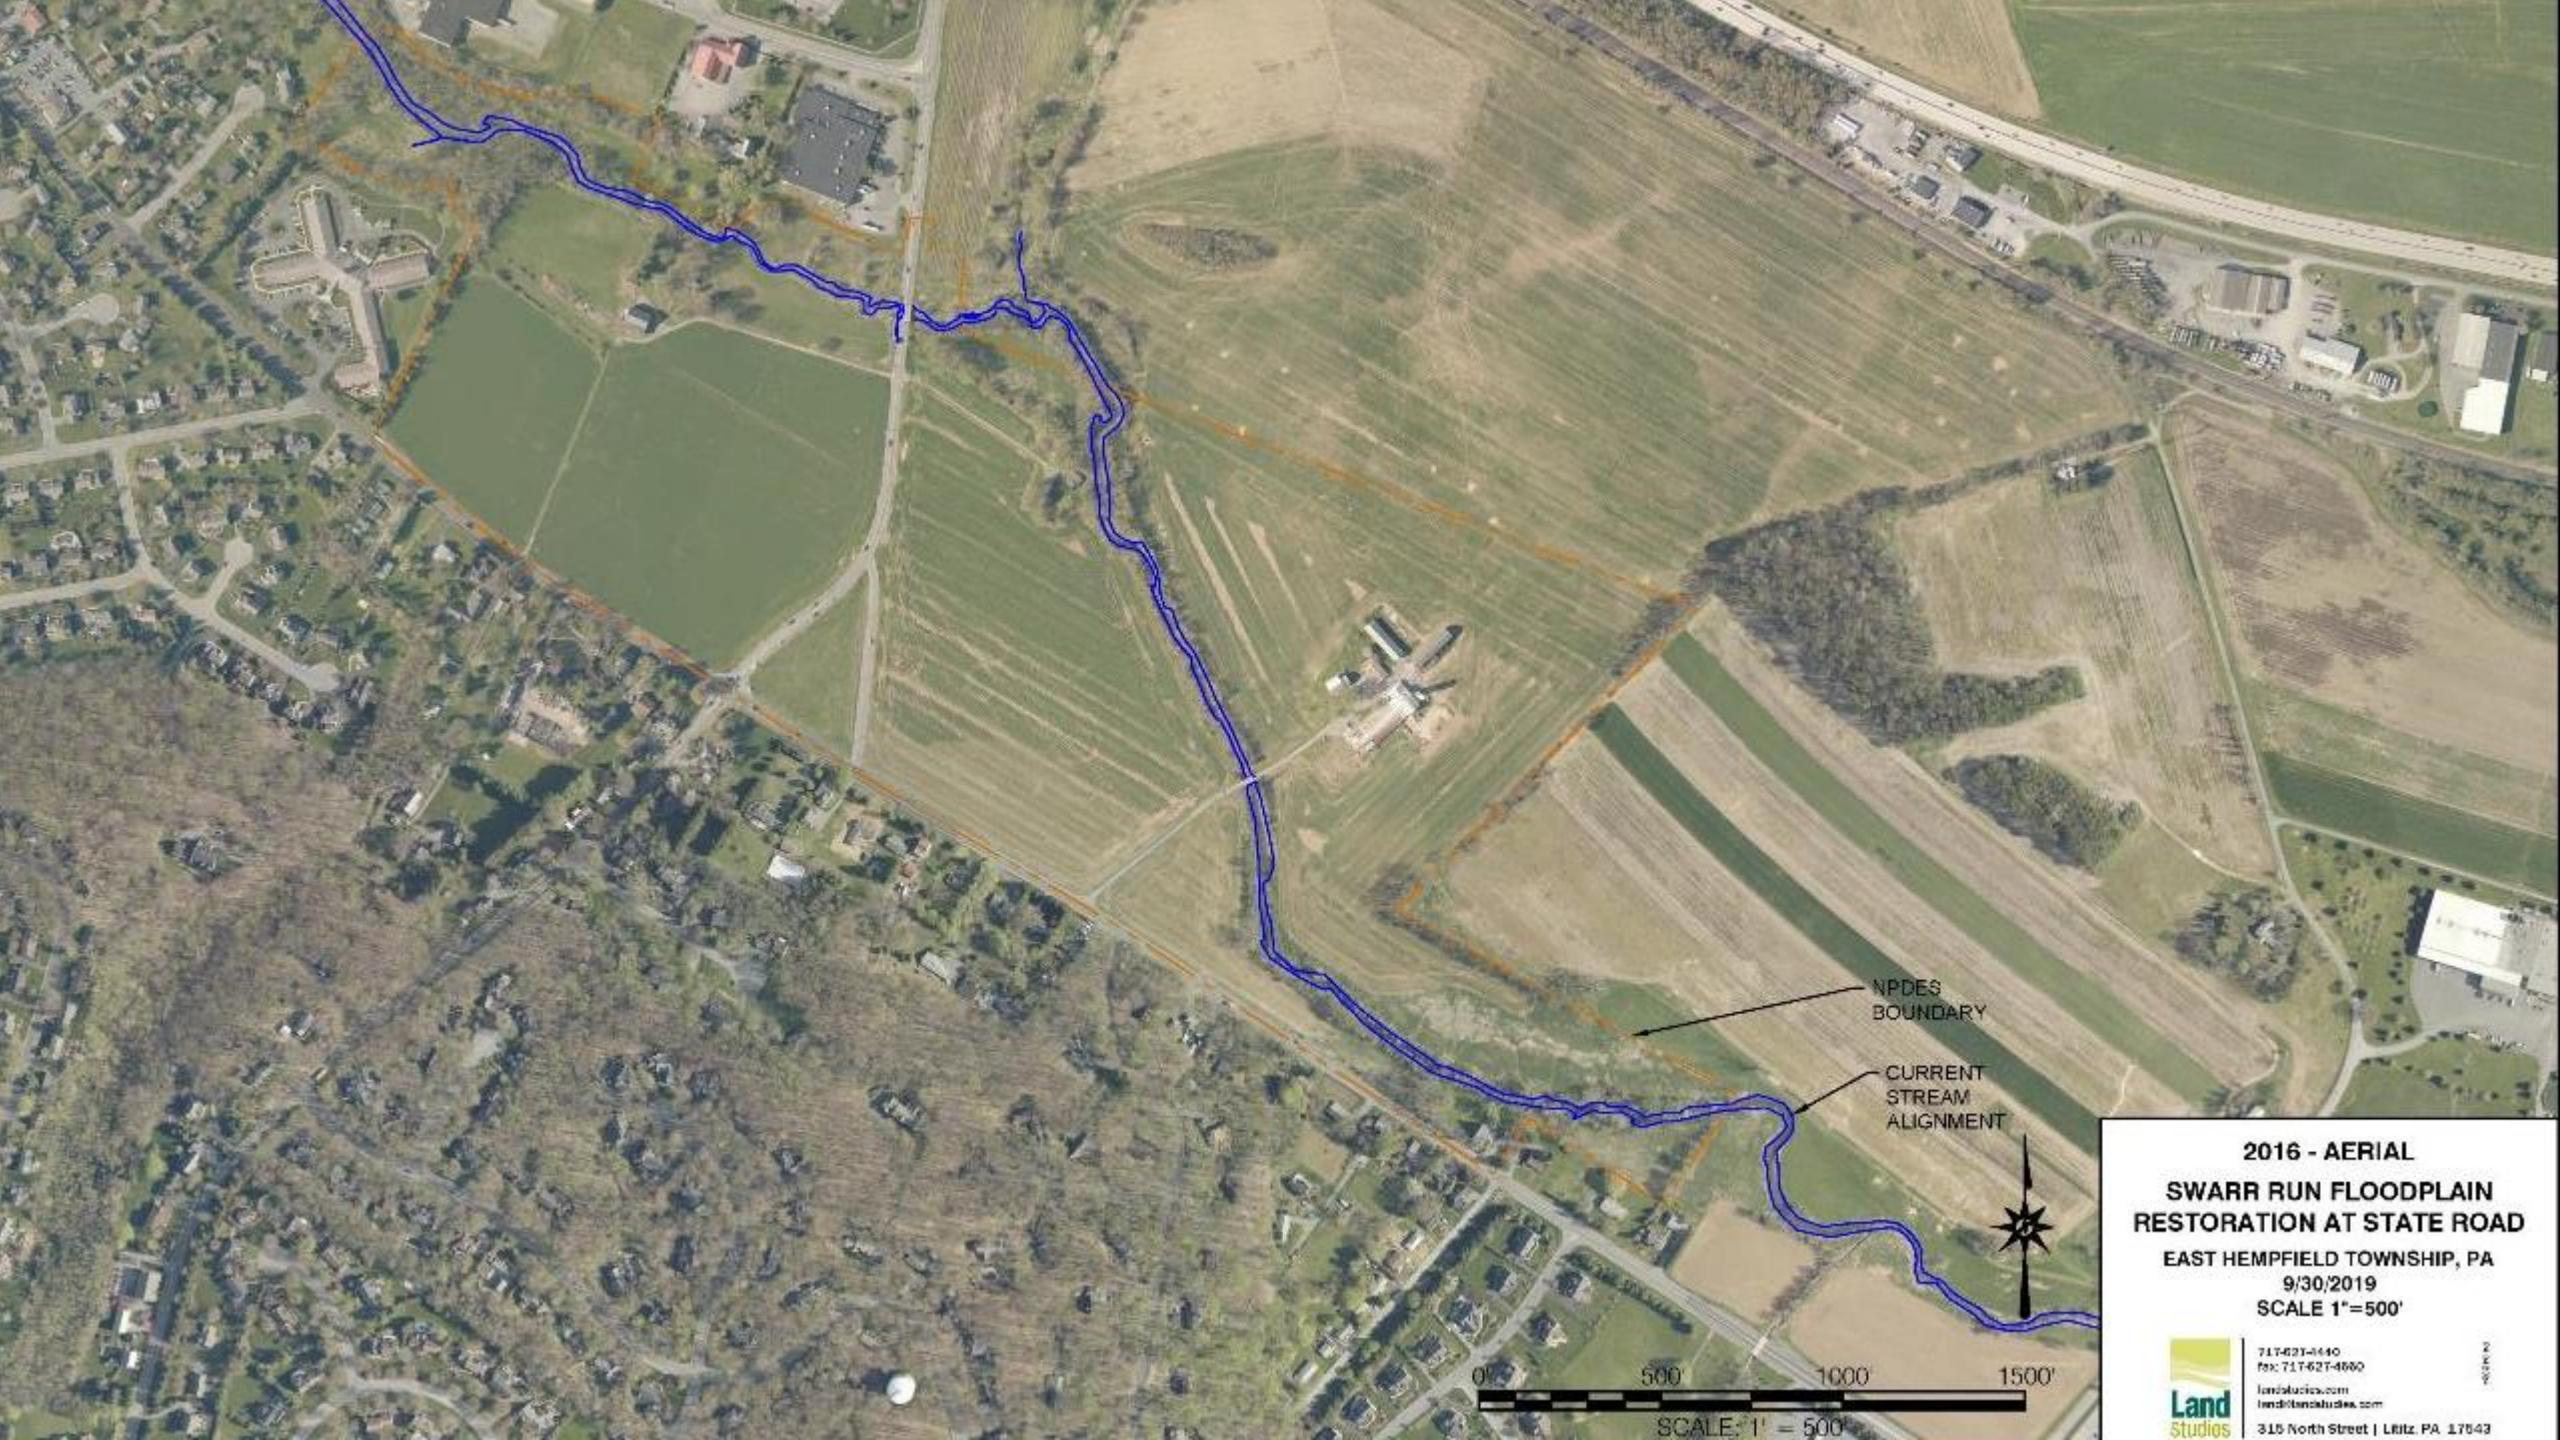
2016 - AERIAL
SWARR RUN FLOODPLAIN RESTORATION AT STATE ROAD

EAST HEMPFIELD TOWNSHIP, PA

SCALE 1"=500'

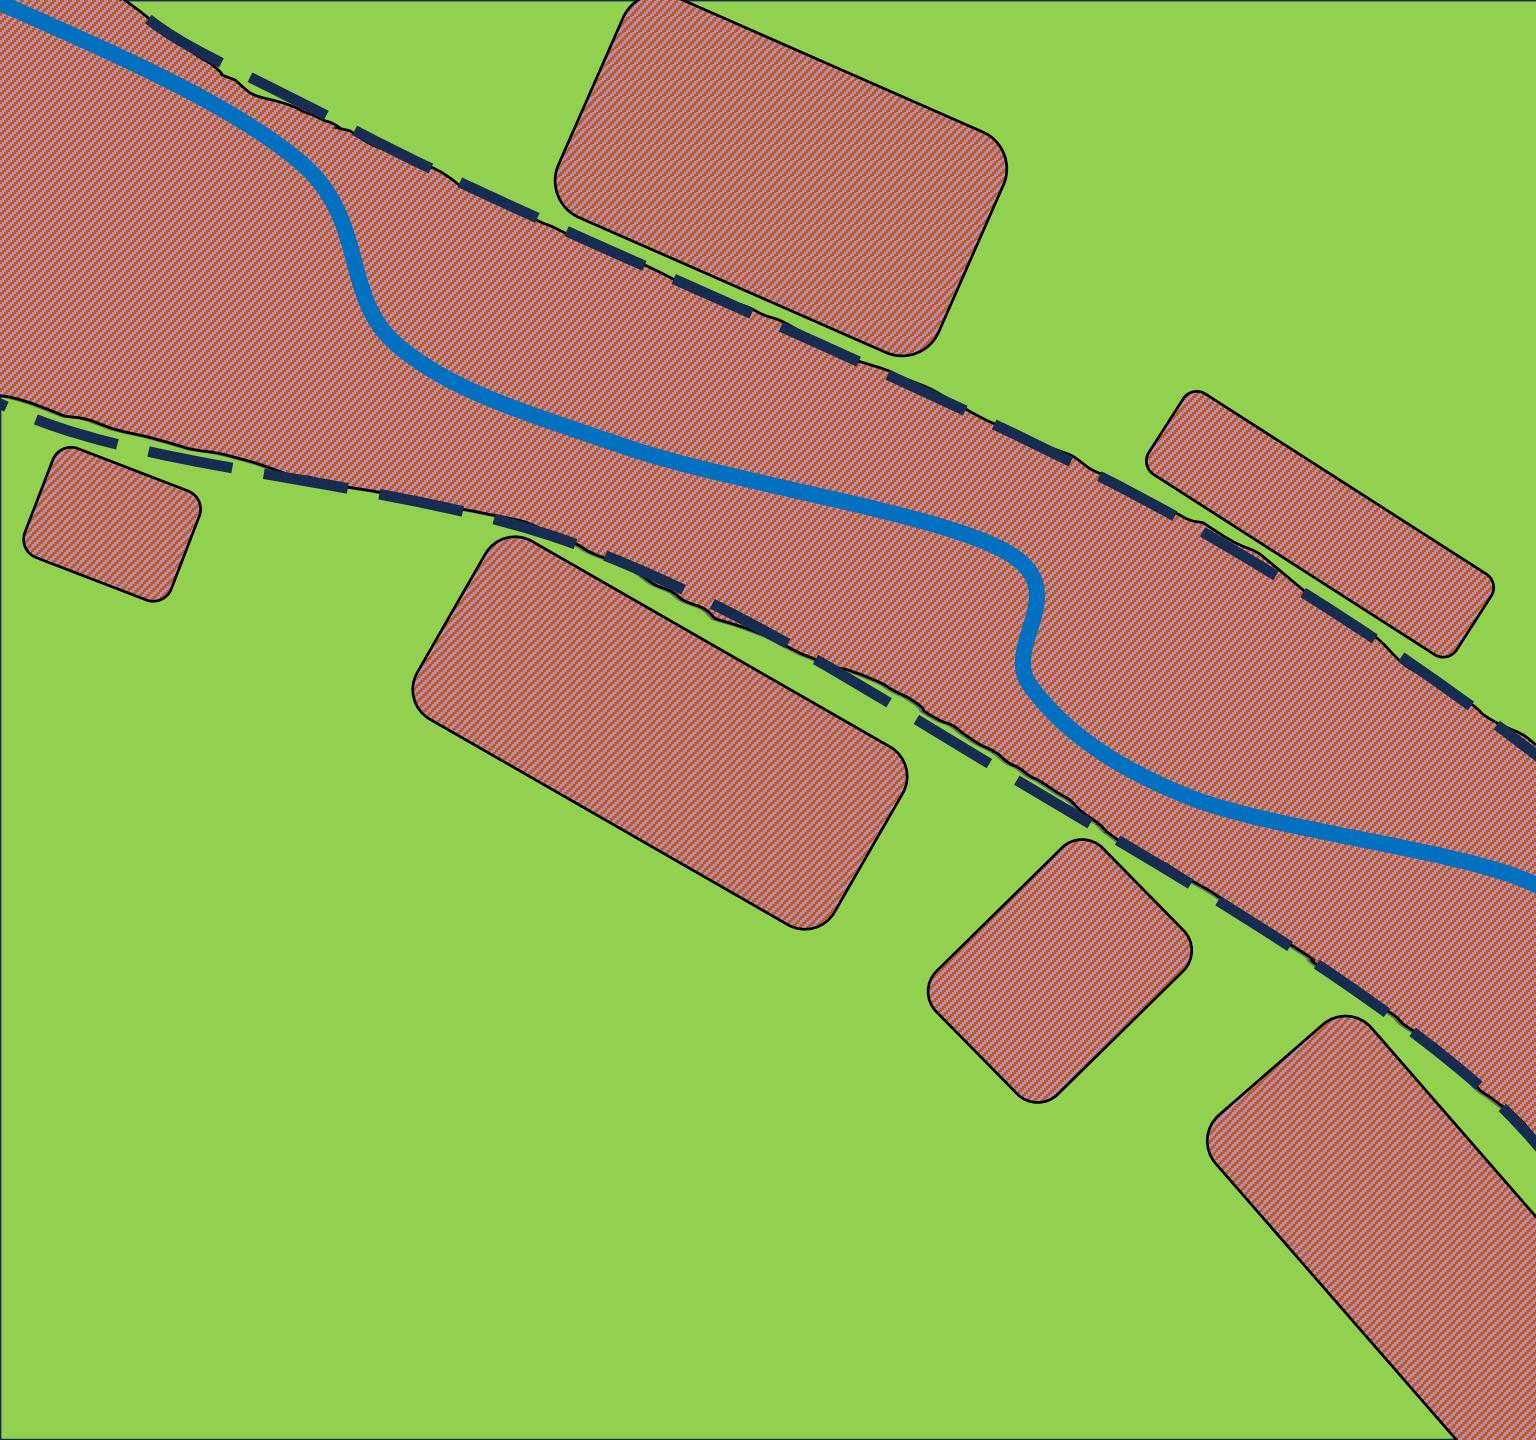
Property 100 Acres
Floodplain
Restoration -20 Acres

Remainder 80 Acres

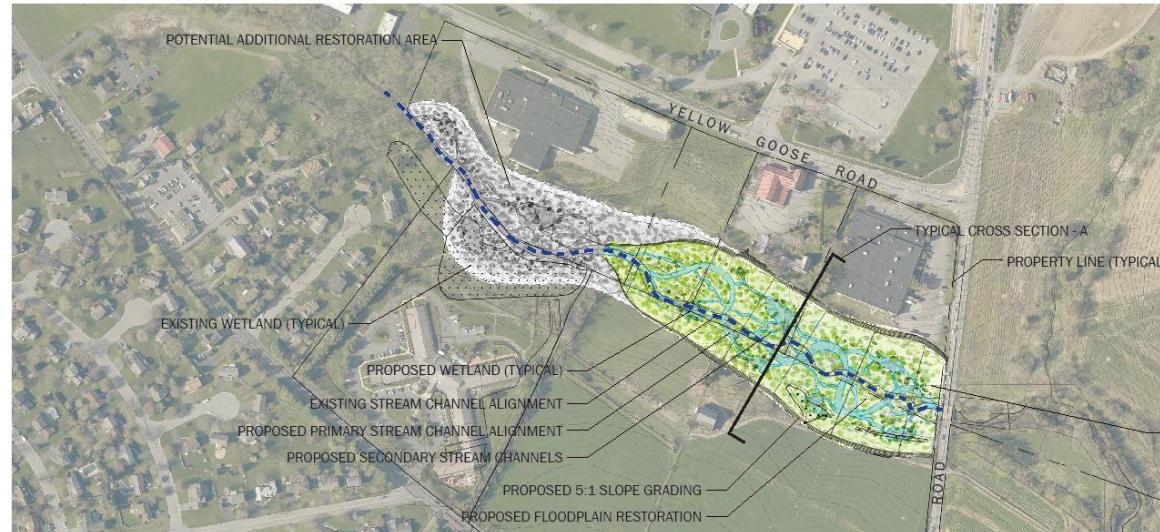
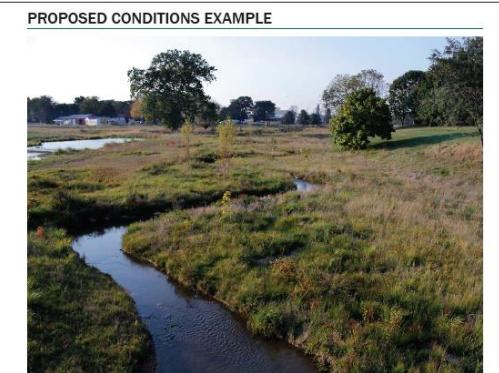
- Constructed in 2020 (Phase I)
- 17-acre project area
- 80,000 cubic yards of legacy sediment removed
- 3,489 linear feet of restoration
- 12.9 acres of Wetlands
 - 11.8 acres restored
 - 1.1 acres rehabilitated

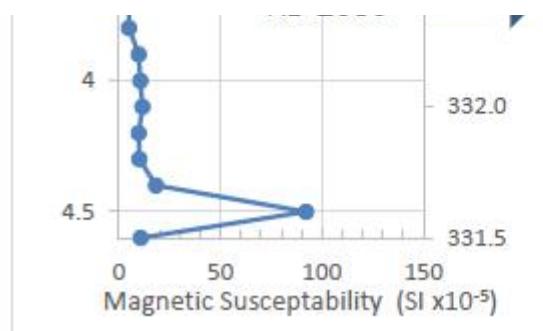
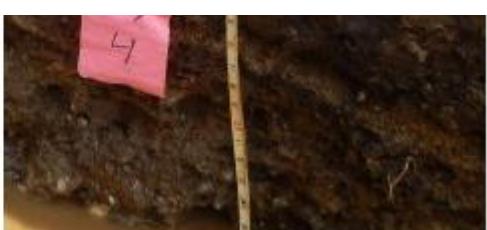
Figure 13 - Soil Profile (Valley Station 23+25)

6653 JS2 Lancaster, PA. Trench 23+25: 3.5' Depth

3.5-4.7 -- -- Gravel -- -- 80%
Small sub-angular quartz basal gravels. Larger gravels interspersed. Some coarse sand, dark brown color.
