Sandhills Mitigation Bank.

Lexington County, **South Carolina**.

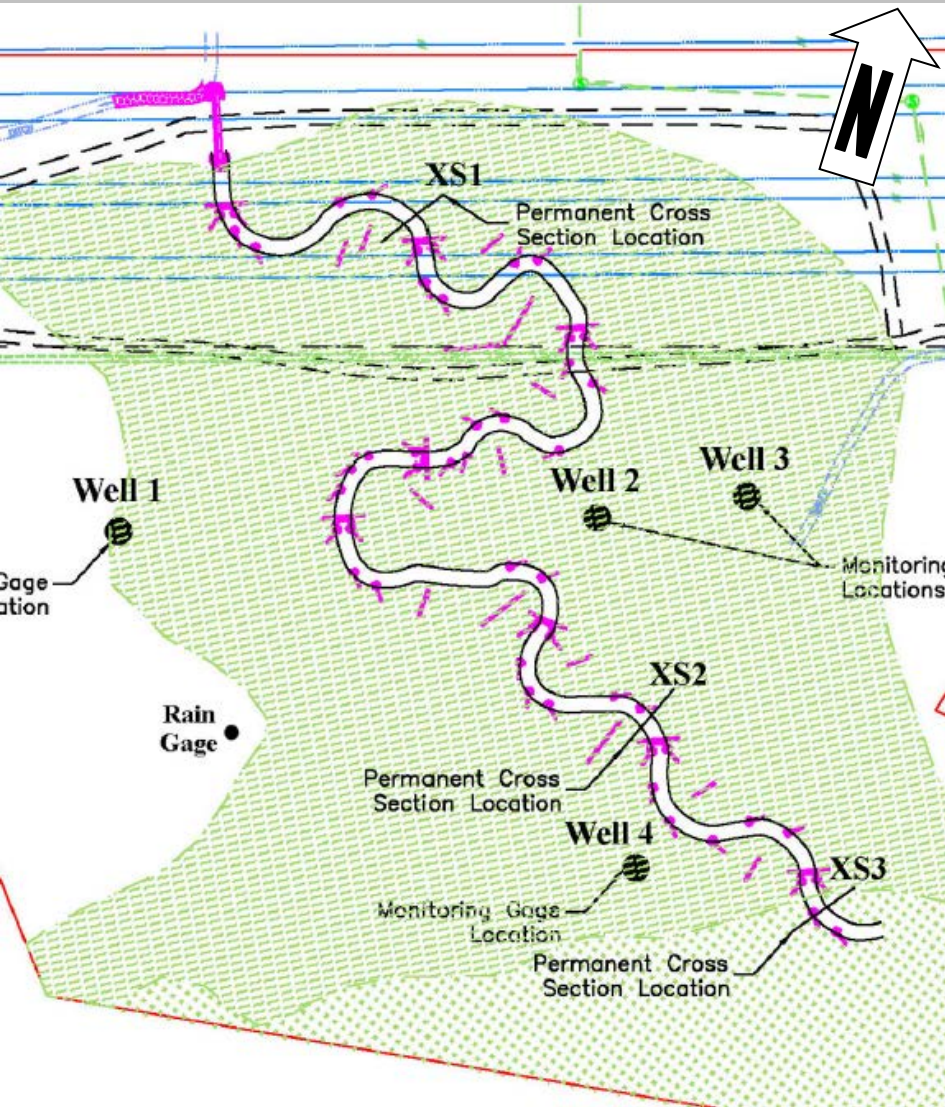
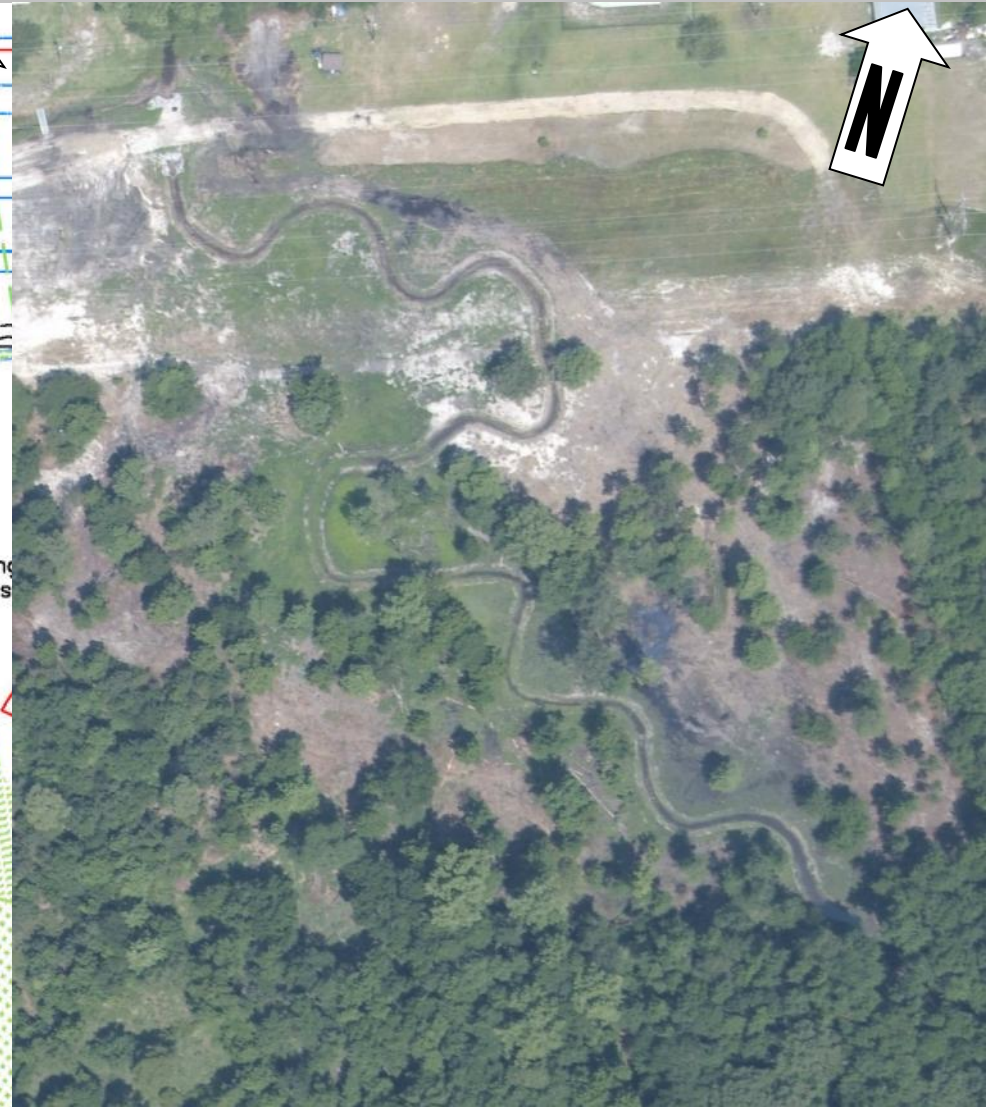
Design (left) and as built in 2006 (right).

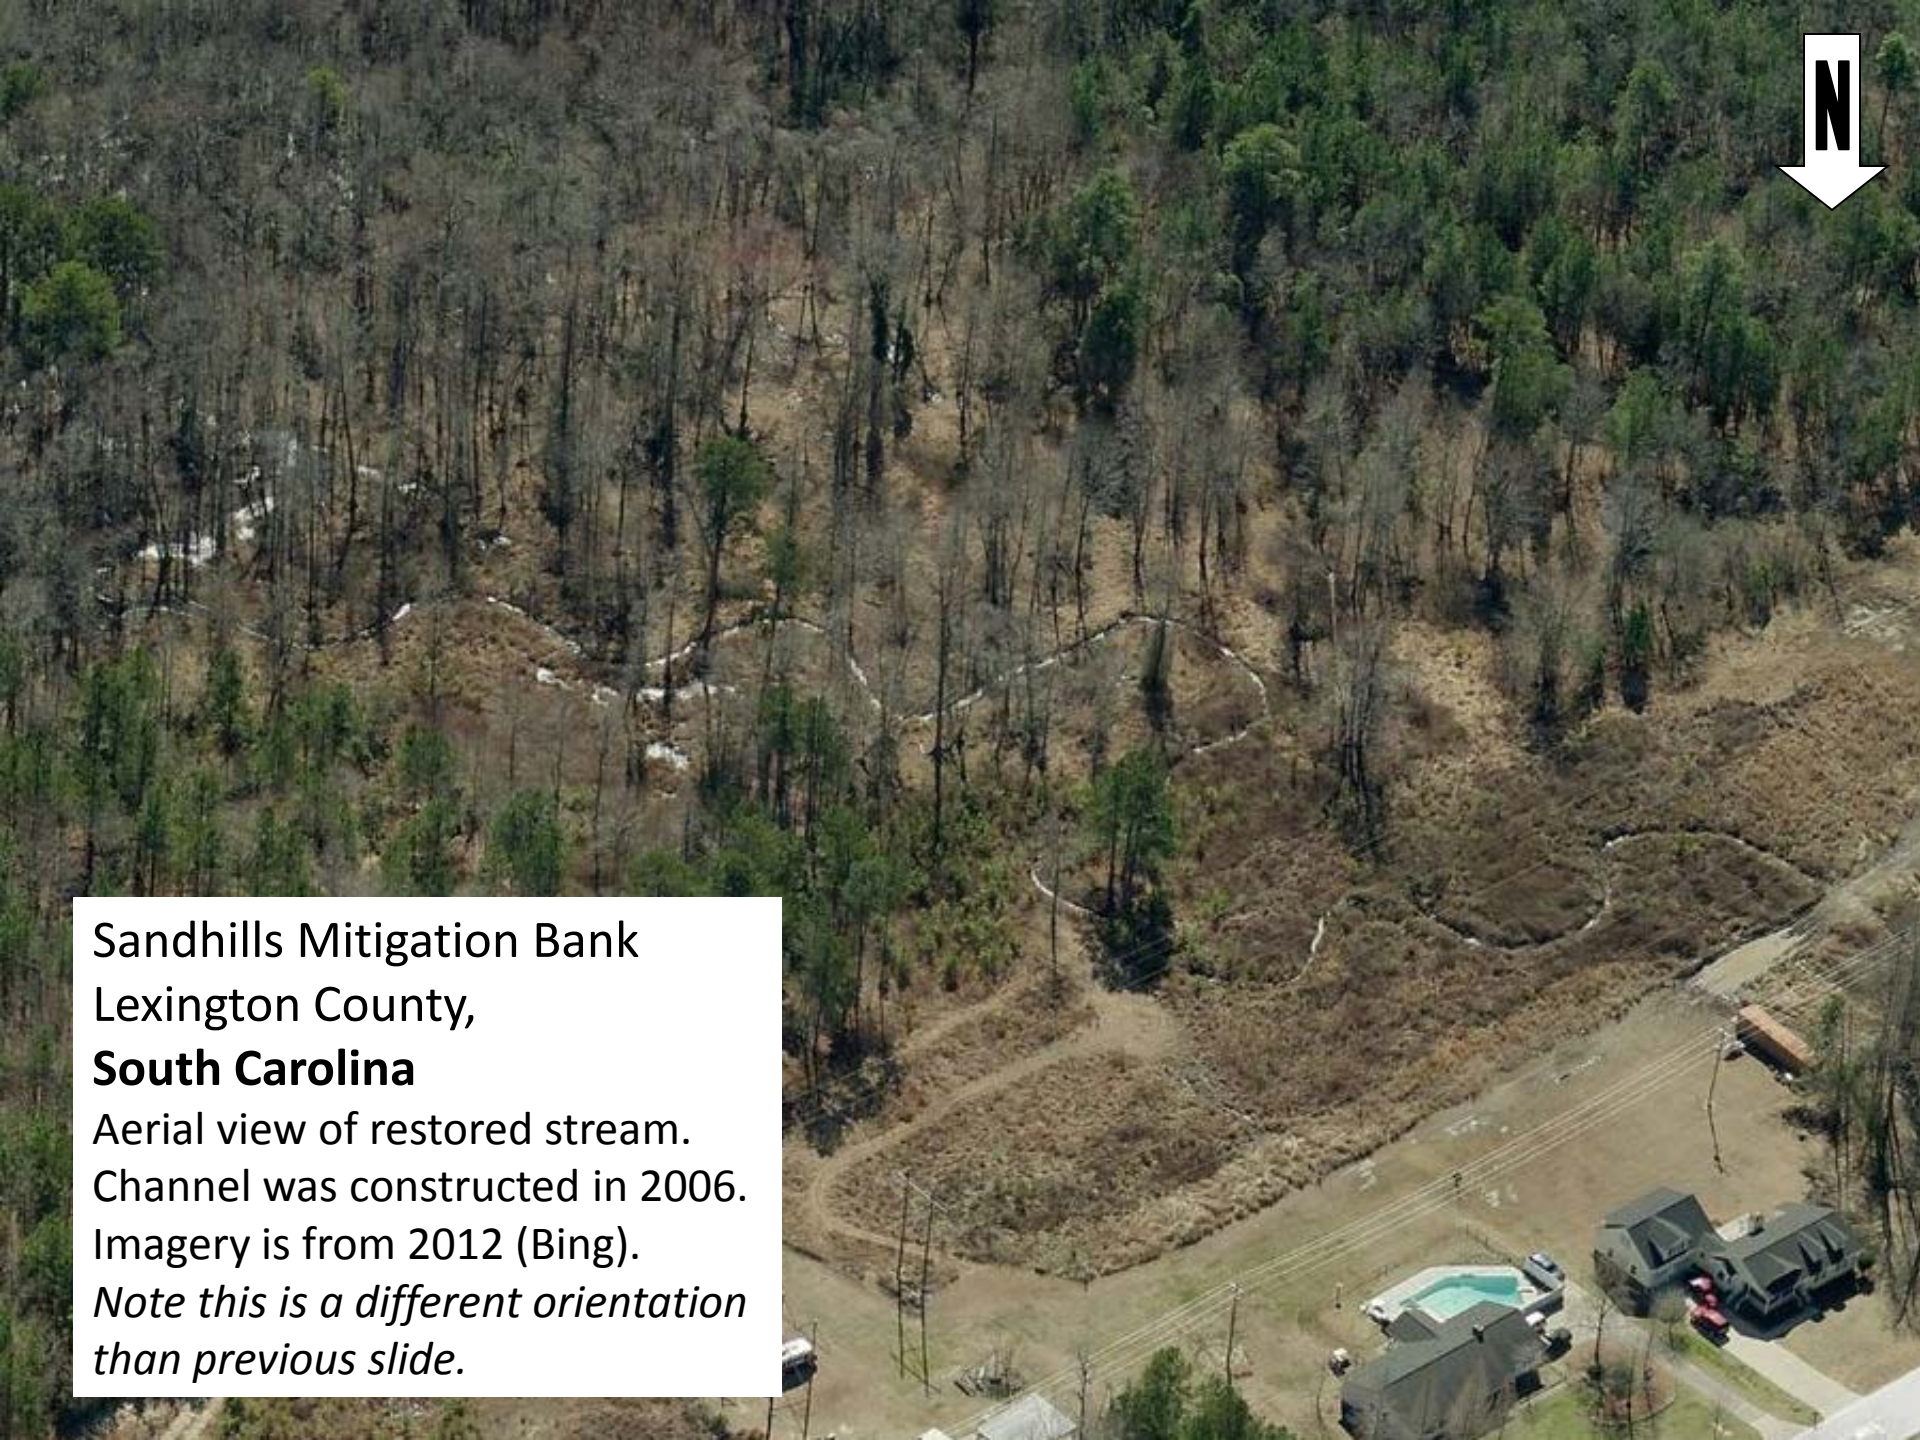
Aerial view of restored stream.
Channel was constructed in 2006.
Imagery is from 2012 (Bing).
*Note this is a different orientation
than previous slide.*
